PLAINTIFFS' EXPERT DISCLOSURE OF THIAGO E. MARQUES

I was asked to inspect the 2003 Hummer H2 which is shown in the photographs that are being submitted with this report, and to determine whether I could re-attach the interior plastic panel of the front passenger door to the metal frame of the front passenger door of the Hummer so that the interior plastic panel would be in its original and proper position, and when I determined that I could, to go ahead and do so. As part of this process, I visited on July 26, 2019 and again on June 7, 2021, East Coast Gas and Auto Repair at 1462 Main Street in Reading, MA, and considered facts and data as is described below:

July 26, 2019 Visit

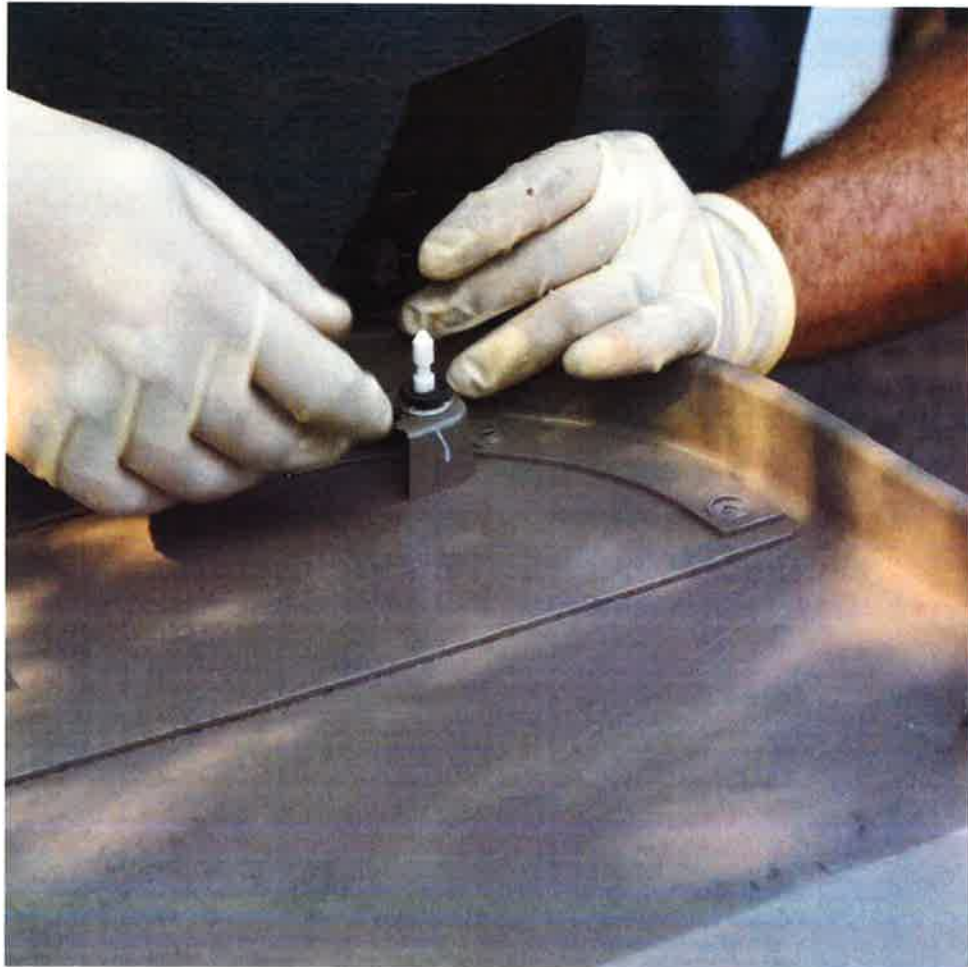
DSC_0101

- Photograph **DSC_0101** shows as an example a replaced white retention clip.
- Photograph **DSC_0103** shows as an example a replaced black retention clip.

I used retaining clips to place the interior plastic door panel in its original position (See **DSC_0101, 0103 & 0121**). These retaining clips extend (a) from certain points in the inner side of the plastic interior door panel, (b) to receptacles in the metal frame of the front passenger door (See **DSC_0122, 0133**). These points in the plastic door panel and receptacles in the metal door frame are aligned, and set by General Motors, so by using these retaining clips and pre-set points and receptacles, I was able to re-attach the interior plastic panel to its original and proper position into the metal frame of the door.

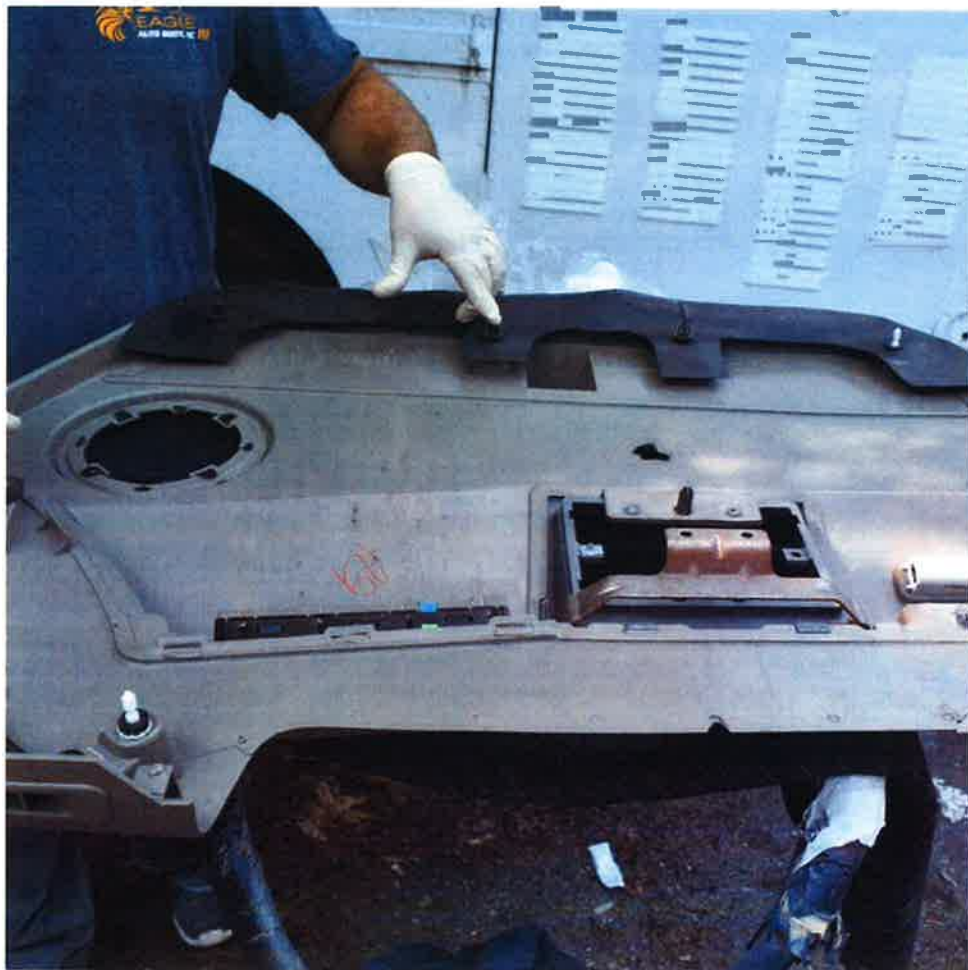
DSC_0121

- Photograph **DSC_0121** shows the interior plastic panel of the front passenger door, which was detached from the metal door frame for that door when I first arrived at East Coast Gas. This photograph shows the side of the plastic door panel that faces the metal door frame when this plastic panel is inserted into the metal door frame. In this photograph, I am pointing to black retaining clips. There are also white retaining clips shown in the photograph. When inserting this plastic panel into the metal door frame, these clips are inserted into receptacles in the metal frame of the door, which engage the clips. This causes the inserted retention clip to secure the plastic interior panel to the door, and to align the panel to the metal door frame such that the position of the interior plastic door panel is in its original and proper position.

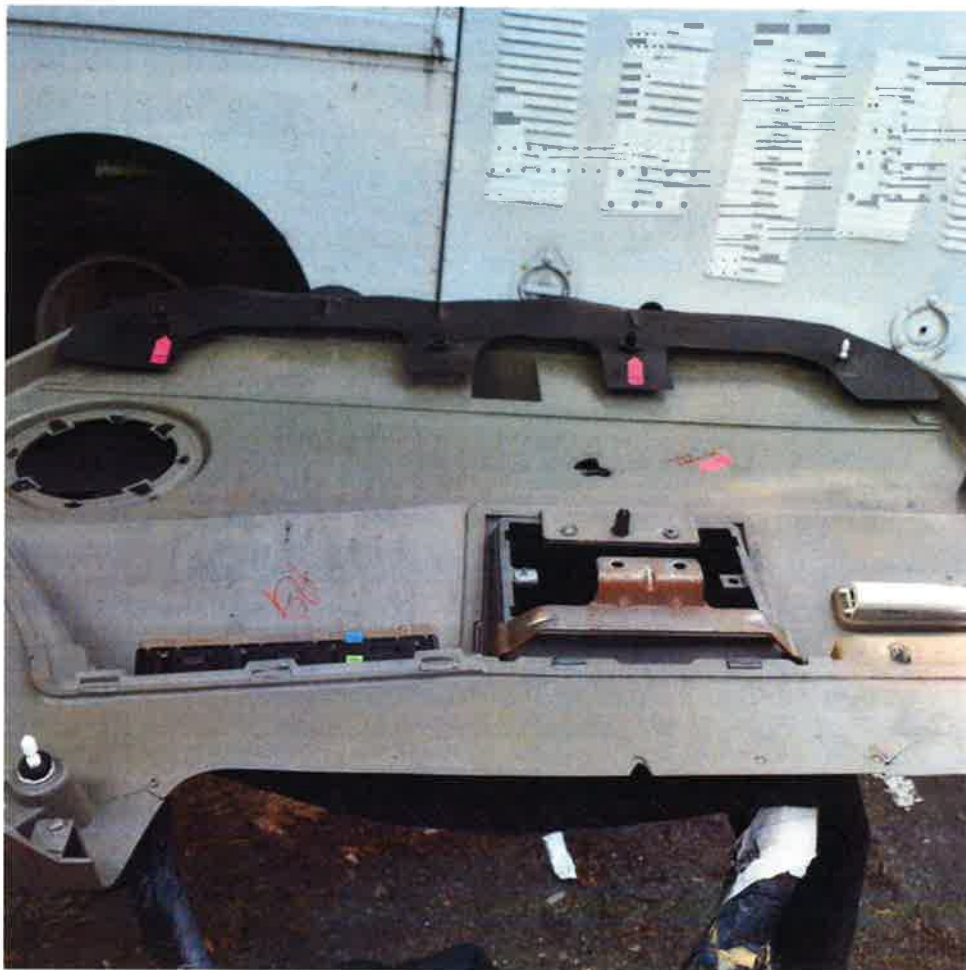
DSC_0122

- Photograph **DSC_0122**, and **DSC_0130** identifies the retention clips that I had to replace, because the original ones were missing or damaged. I designated in these photographs the clips that I replaced by placing a purple sticky adjacent to them. However, the purple sticky that Photograph **DSC_0123** shows does not designate a replaced clip; it is only a note as to what the other purple stickies designate.

When I re-attached the plastic door panel to the metal frame of the front passenger door, several of the retaining clips were missing or damaged, so I had to replace those clips. I obtained the correct replacement clips from General Motors in accordance with the VIN # of the Hummer (See **Exhibit D**). Also, I know these clips were the correct size because if they were not the correct size, they would not have fit into the plastic panel and the metal frame of the door, and they clearly fit into both of these structures. Any damage to the points in the interior door plastic panel that held the retention clips as well as the wiring in the metal door frame did not interfere in any way with the process of securing the interior plastic panel to the metal door frame, and thus did not alter the position of the interior plastic door panel into the metal door frame.

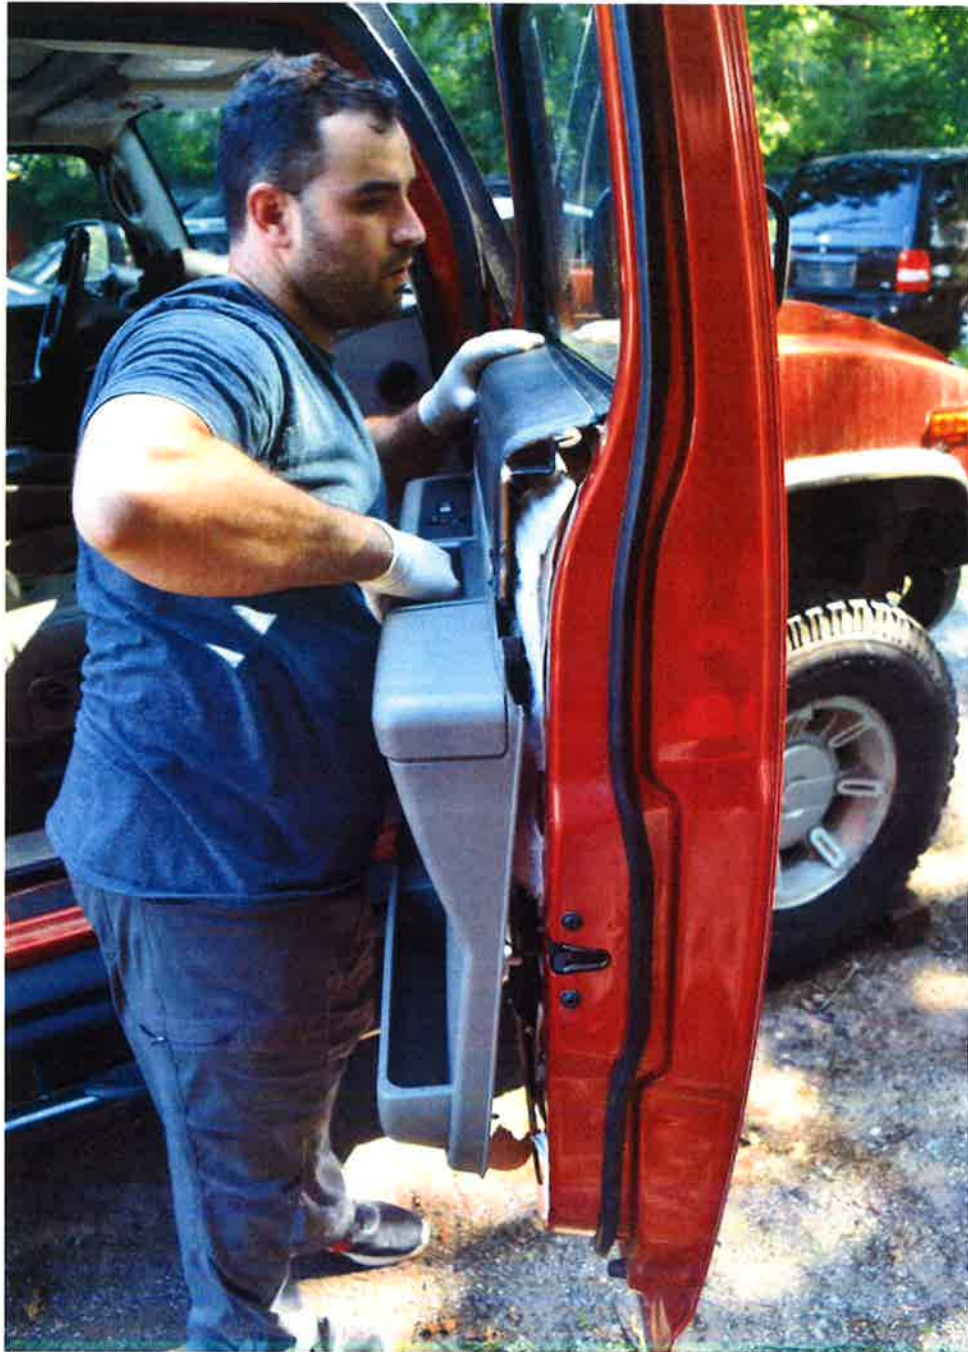
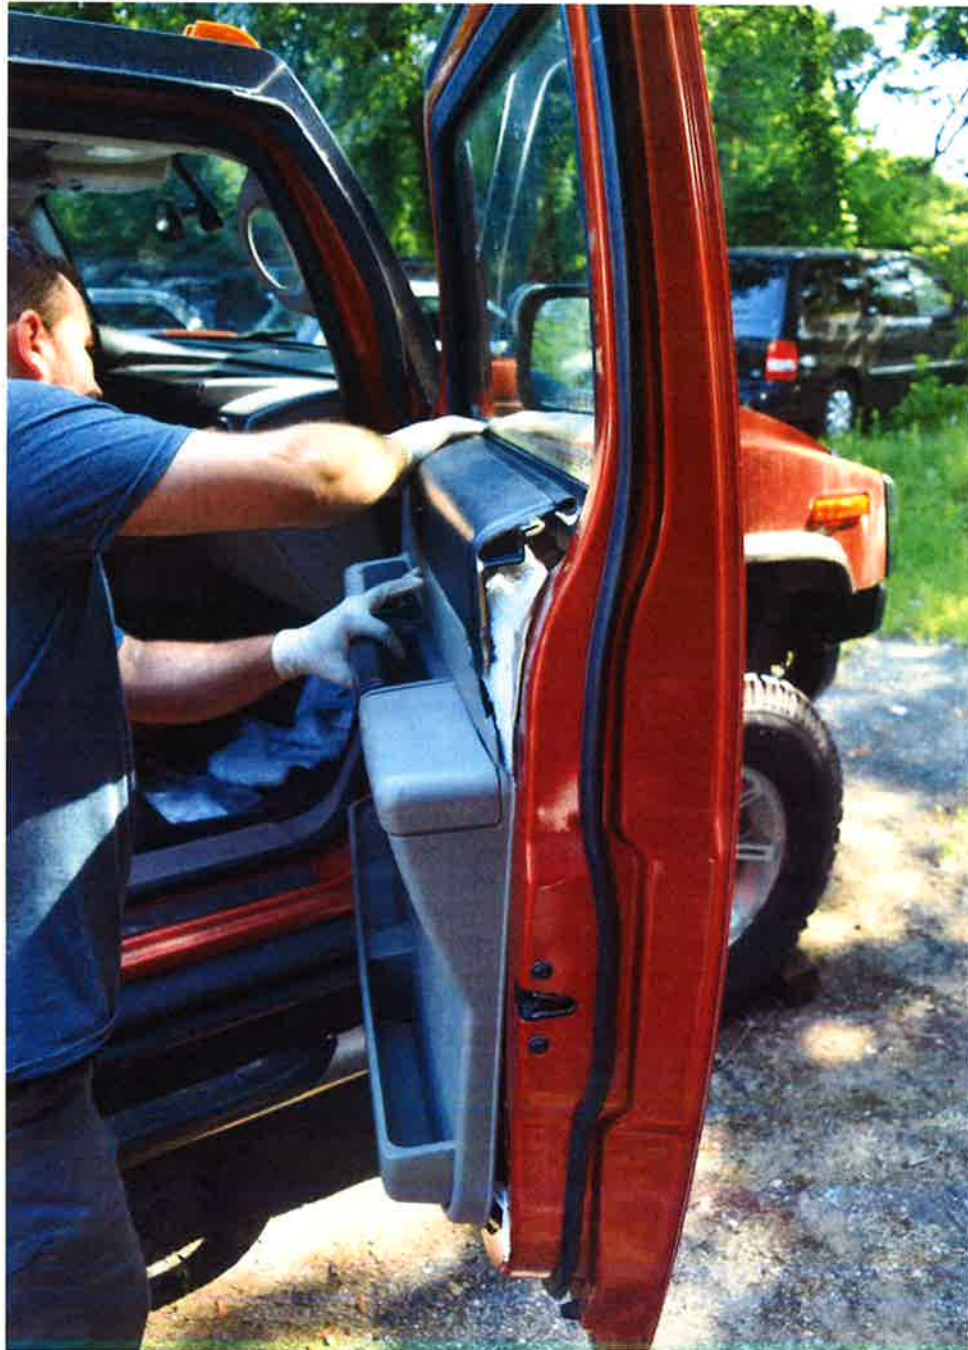
DSC_0146

- Photograph **DSC_0146 & 0147** shows me inserting the interior plastic door frame into the metal frame of the front passenger door by aligning and then inserting the retention clips into their receptacles in the metal door frame.
- Photographs **DSC_0149, 0150 & 0152** show that the interior plastic door panel is properly aligned with the metal door frame.
- Photograph **DSC_0160** shows the two holes in a metal portion of the plastic interior door panel in which bolts are placed such that they extend into the threaded holes just above the handle in the metal frame of the door (See **DSC_0133**).
- Photograph **DSC_0162** shows the interior plastic door panel after I reinserted it into the metal frame of the door.

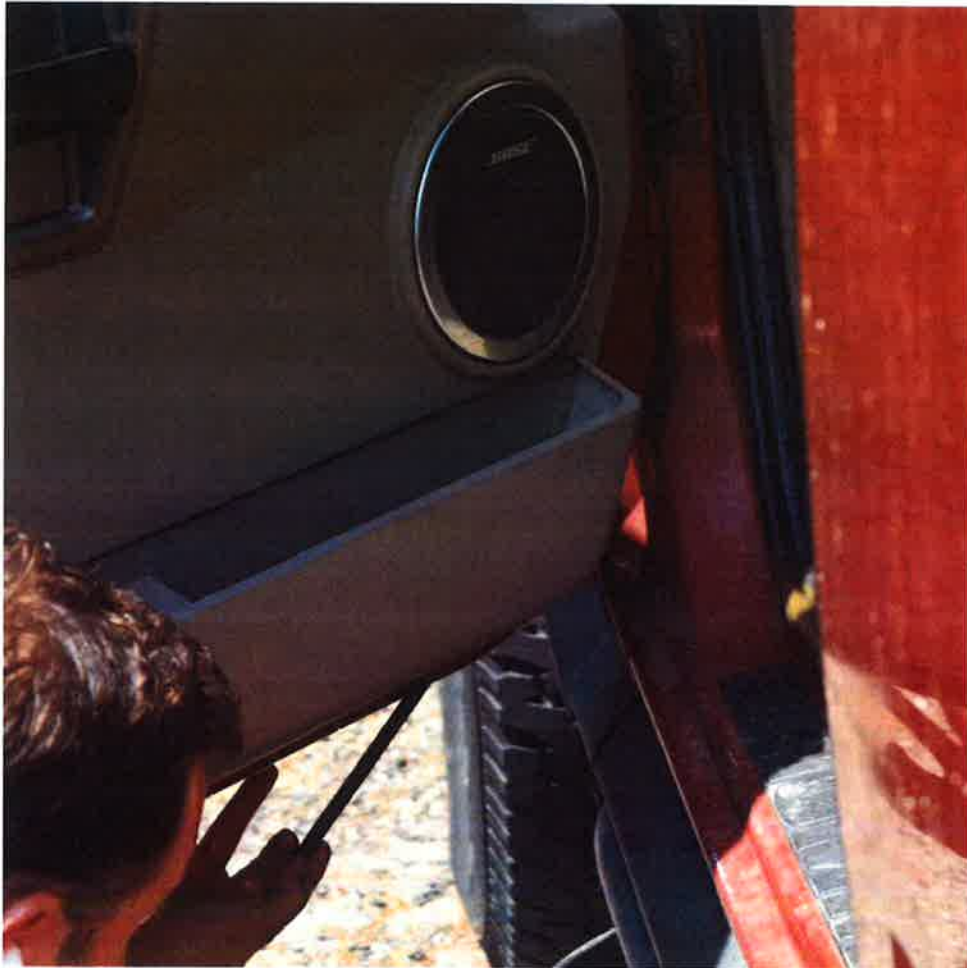
DSC_0672

On June 7, 2021, when I arrived at East Coast Gas, I inspected the Hummer including the exterior and interior of the front driver's and passenger's doors. Attached as **Exhibit B** are Photographs, which are fair and accurate representations of the appearance of the Hummer, the interior plastic panel of the front passenger and driver's doors, and the metal frame of the front passenger and driver's doors. Photographs **DSC_0664, 0665 & 0666** in Exhibit B, show me inspecting the fit between the interior plastic panel and the metal frame of the front passenger door. Photographs **DSC_0671 & 0673** in Exhibit B show me inspecting the fit between the interior plastic panel and the metal frame of the front driver's door.

The photographs to which I refer to in the disclosure that I signed on July 26, 2023 are fair and accurate representations of the items shown in the photographs on the date that the photographs were taken. However, the photograph to which I refer on page 3 of my disclosure regarding my visit to East Coast Gas on June 7, 2021 as “DSC_0673” is a typographical error. It should have referred to as image “DSC_0672.”

In addition, during my visit to East Coast Gas on June 7, 2021, I re-inspected the interior plastic door panel to the front passenger door, and confirmed that the panel was still in its correct position. I looked at certain points in the panel to verify those points were in the correct position, and they were in the correct position; there was no wiggle room. It was an exact fit (**DSC_0664, 0665 & 0666**). In addition, I compared the positioning of (a) the interior plastic door panel to the front *driver's* door (See **DSC_0671 & 0673**), to (b) the positioning of the interior plastic door panel to the front *passenger's* door, and they were consistent with each other and both were

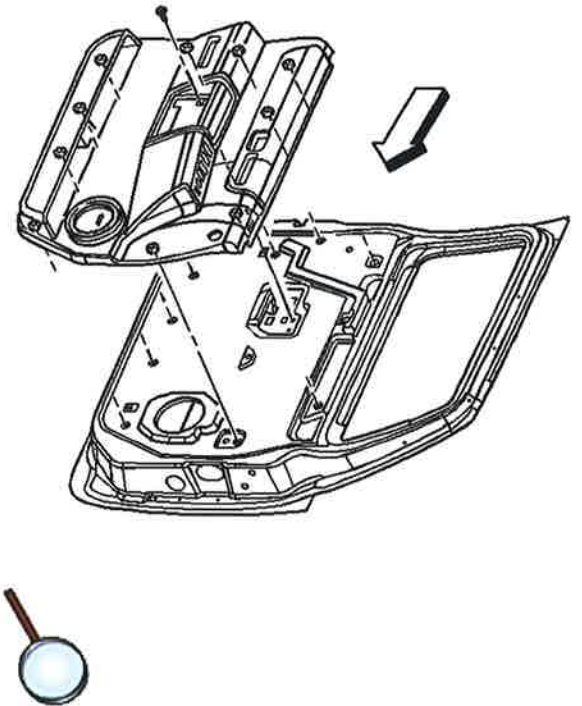
1. Connect the electrical wiring harness connectors.
2. Install the door trim panel to the vehicle.
 - 2.1. Align the door trim panel retaining clips with the openings in the door.
 - 2.2. Push inward on the door trim panel to engage the fasteners.
3. Install the door window switch. Refer to [Door Lock and Side Window Switch Replacement - Driver Side](#) or [Door Lock and Side Window Switch Replacement - Passenger Side](#).
4. Install the door panel retaining screw within the handle bezel opening.
5. Install the door handle bezel. Refer to [Front Side Door Inside Handle Bezel Replacement](#).

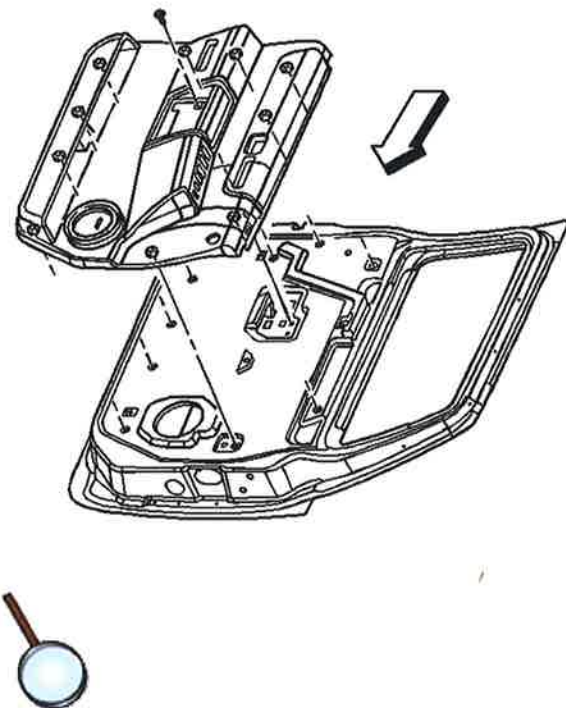
1. Remove the door handle bezel. Refer to [Front Side Door Inside Handle Bezel Replacement](#)
2. Remove the door panel retaining screw located in the handle bezel opening.
3. Remove the door window switch. Refer to [Door Lock and Side Window Switch Replacement - Passenger Side](#).
4. Use special tool **J 38778** to release the door trim panel retaining clips.
5. Disconnect the electrical wiring harness connectors.
6. Remove the door trim panel from the vehicle.
